MUNICIPALITY OF SAN VINCENZO LA COSTA

**INTERVENTIONS TO IMPROVE THE NETWORK EFFICIENCY
MUNICIPAL PUBLIC LIGHTING**

REL.01

GENERAL REPORT

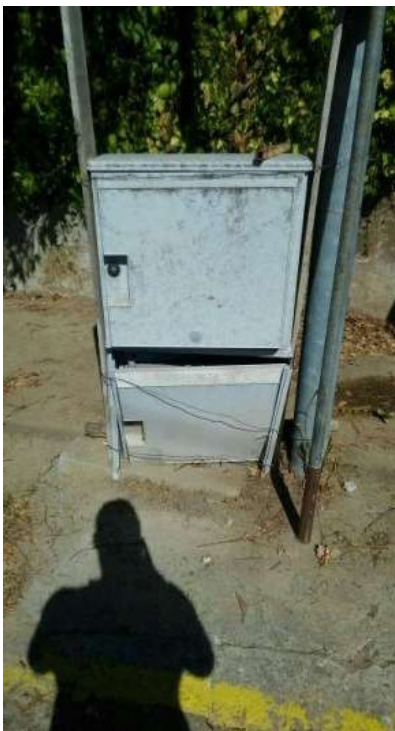
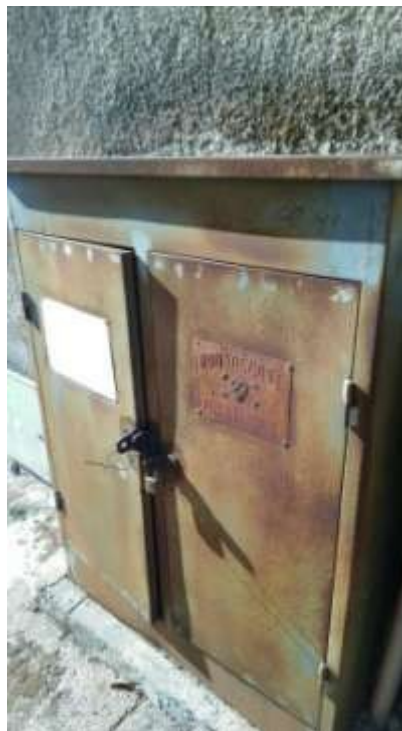
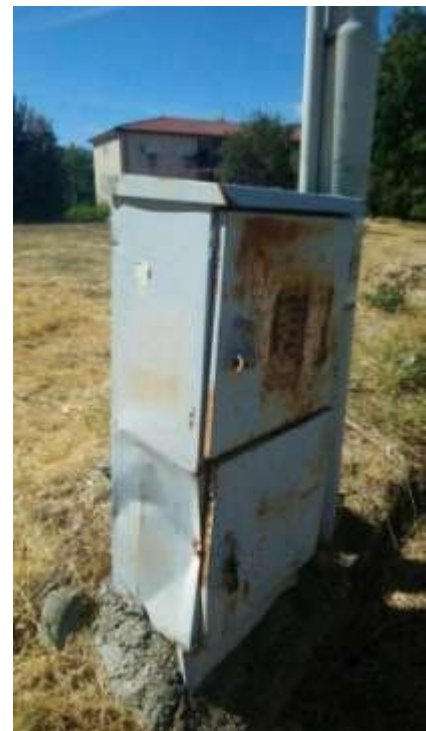
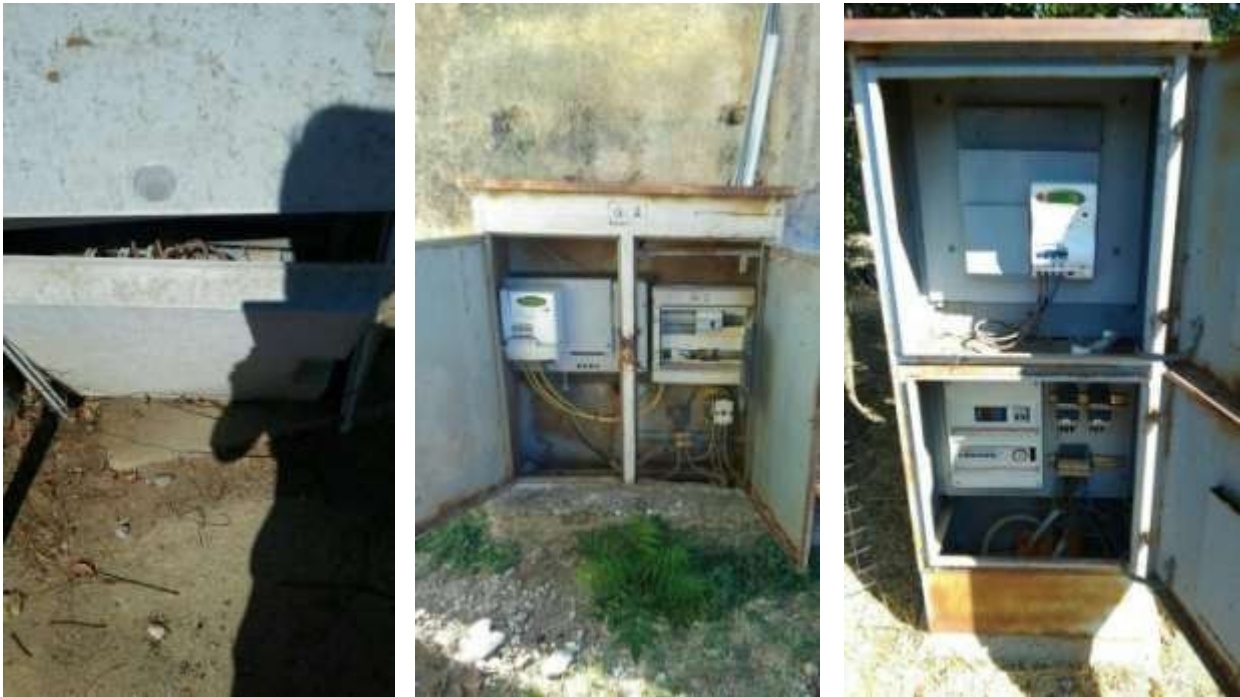
Fig.2. Types of paintings present in the territory

The power and control systems are housed inside street cabinets, which are mostly made of fiberglass, with the remaining parts made of iron. The iron cabinets require painting as they are in a very corroded state and some of them have irregular closures, so much so that they cannot guarantee public safety in the event of accidental openings.

Even the state of conservation of the electrical equipment itself is, for some panels, in such a state as to require immediate replacement with new components.

- Total remake of panels, consisting in the complete removal of existing cabinets and installation of new street cabinets, appropriately protected with shock-proof systems and containing all the electrical and auxiliary equipment necessary for the protection of the lines and end users, as well as systems capable of allowing punctual supervision of the systems

- Bringing it into compliance with paintings, by inserting special protection devices electrical devices such as differential circuit breakers, surge arresters, sectional switches, etc.;

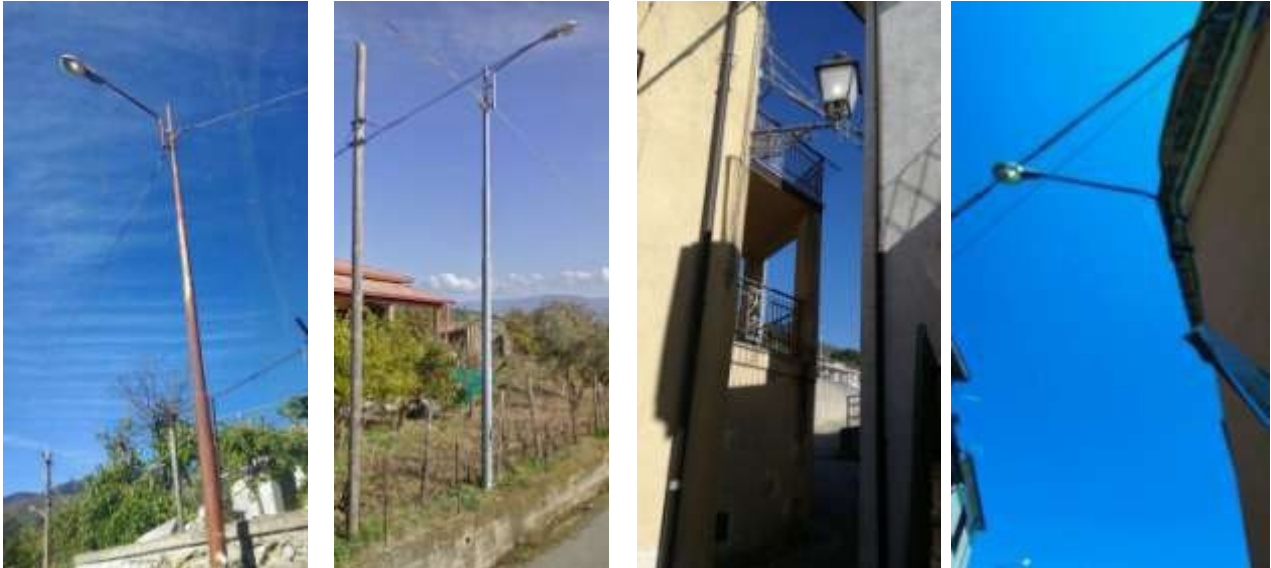
Fig.3. Types of supports present in the territory

At present there are parts of the supports that appear to be in a serious state of degradation, with corroded parts. Furthermore, there are 3 pole-type supports that appear to be in a precarious state of equilibrium and with the possibility of causing damage to public safety. It also emerged that there are 60 iron arms with road reinforcements that do not comply with current ones. regulations and not appropriately inserted into the urban context in which they are located (Historic Centre).

3. Replacement of n°3 existing poles with new ones in galvanized steel , of such dimensions and shape as to achieve the best lighting results on the road served;

4. Painting of n°230 supports which are in a highly corroded state using anti-corrosive oil-

5. installation of new artistic shelves , aesthetically similar to those already existing in place of the non-artistic arms present in the historic centre and in the hamlets of Gesuiti and San Sisto dei Valdesi.

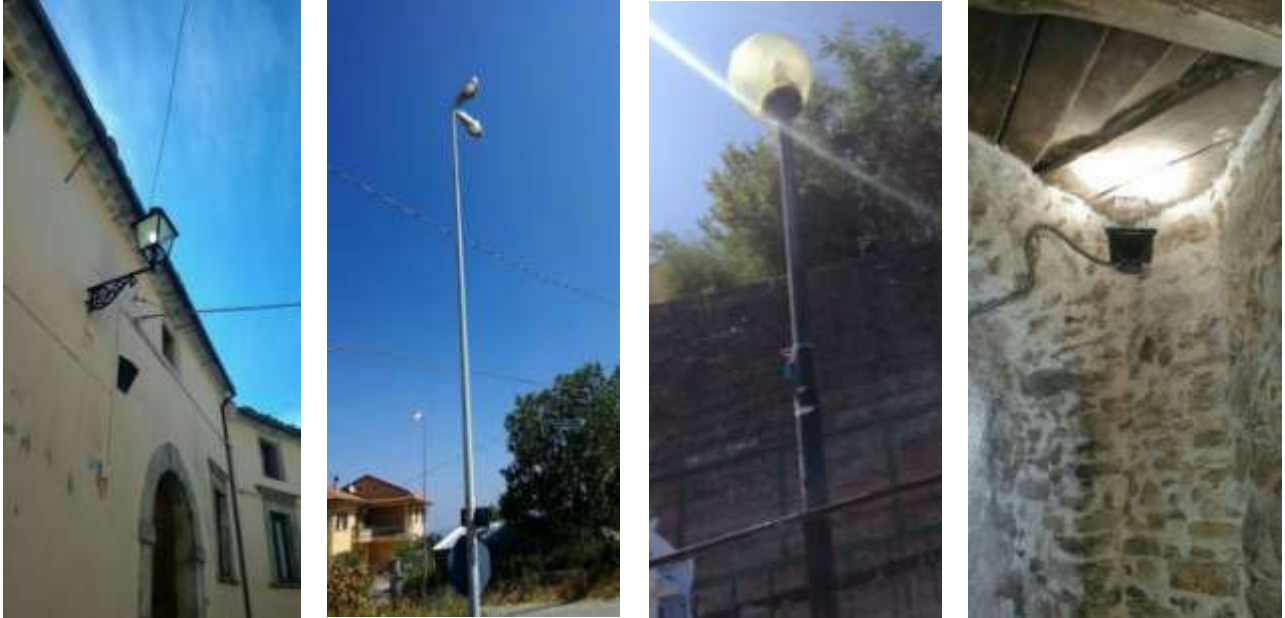
Fig.4. Types of lighting fixtures present in the territory

The public lighting system features, as specified in the table above of LED lighting fixtures, the following project does NOT intervene on these lighting fixtures as they are already made up of latest generation lamps, however it should be noted that they have obsolete or poorly maintained fittings and for these reasons do not allow for correct street lighting.

2. Replacement of 703 existing light fixtures with new LED fixtures , this intervention of greater consistency than the others described, will allow to obtain many of the advantages stated above, as it will allow to reduce the energy costs of the system (being LED equipment capable of guaranteeing greater efficiency compared to traditional sources), of abbato direct the light emission above the lighting fixtures, to improve current lighting performance, through the use of lenses capable of distributing the light flow where actually necessary (reducing debilitating glare, illumination invasive in private areas, etc.), to reduce current maintenance costs, thanks to the lifespan of such innovative equipment (estimated lifespan between 60,000-80,000 hours of operation, even more reliable if served by flow regulation systems, capable of prolonging the useful working life). This intervention includes the replacement of 538 road armor,the replacement of 133 of typeartistic (which oneslanternspresent in the historic centre of the municipality, and in the hamlets of Gesuiti and San Sisto dei Valdesi), but also the replacement of 19 armors on globesand of 12 armors divided between projectors and tensioned armatures. The new equipment will be of the double-insulated type, therefore it will not be necessary ,It is forbidden to connect them to the earthing system, with obvious advantages in terms of system management.
